# Alkali-Silica Reaction

## An RJ Lee Group Materials Insights Article

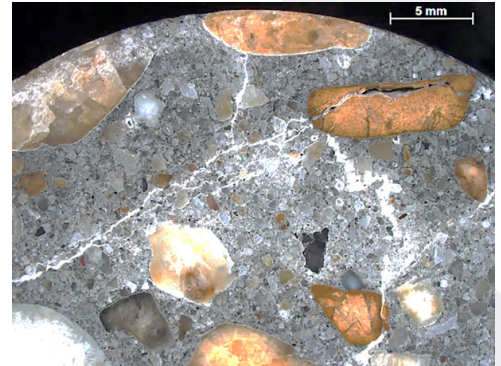
Figure 1. Reflected light micrograph of ASR-affected concrete, showing gel-filled microcracks in the cement paste and aggregate particles.<sup>6</sup>

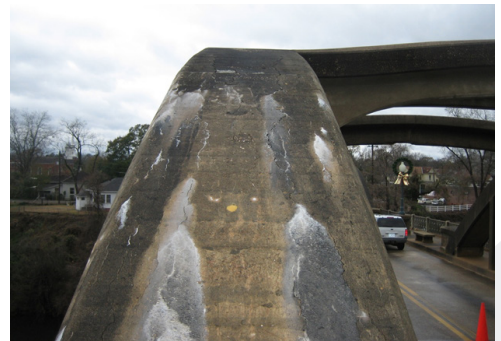
Figure 2. ASR-affected Bibb Graves Bridge in Wetumpka, Alabama, showing cracking and gel exudation features.

Diagnosis of ASR typically begins with visual inspection prompted by the presence of characteristic surface features, such as macro-cracking, gel exudation and staining along the cracks, closing of expansion joints, and even localized crushing (blowups) in pavements. Cracking in reinforced concrete is typically aligned preferentially with the primary reinforcement (Fig 2), while in unrestrained plain concrete the cracking is more random and commonly referred to as map cracking (Fig 3). Many of these visual features can also be caused by other deterioration mechanisms such as drying shrinkage, freezing-and-thawing, and delayed ettringite formation (DEF), or a combination of mechanisms that may include ASR. Therefore, visual inspection in the field must be supplemented by laboratory analyses, including concrete petrography, to determine the cause(s) of the concrete deterioration.

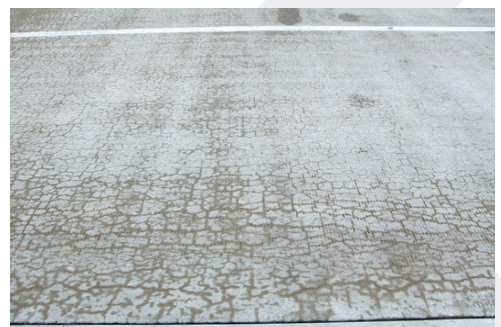
Figure 3. Example of map cracking in unreinforced concrete airfield pavement.

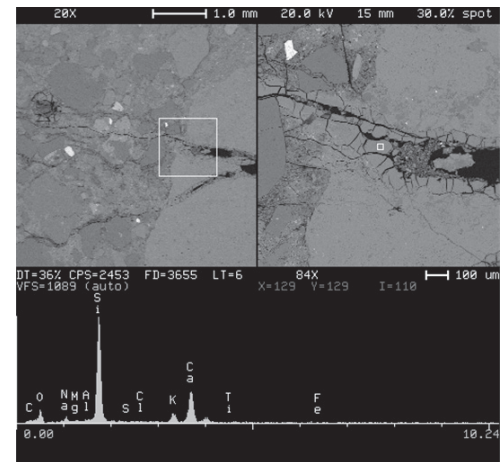
Figure 4. SEM imagery of fresh ASR gel with a “cracked mud” texture at the mouth of a crack in an aggregate particle, with EDS point spectrum showing the presence of sodium (Na), potassium (K), and silicon (Si) in the gel.

Petrographic examination of concrete core samples (ASTM C856) and Scanning Electron Microscopy (SEM) analysis (ASTM C1723) can be used to identify the presence and extent of ASR. SEM analysis is particularly useful in positively identifying the presence of ASR gel. The gel has a characteristic texture resembling cracked, dried mud (Fig 4).

The reaction starts within a cracked aggregate and propagates into the cement paste. Energy dispersive x-ray spectroscopy (EDS) is combined with SEM analysis (SEM-EDS) to determine the elemental composition of ASR gel, which is primarily silicon, with lesser amounts of calcium and traces of potassium and sodium (Fig 4).

Fresh, or recently formed, gel is relatively high in silicon, potassium, and sodium. Over time, calcium ions from the pore solution will replace sodium and potassium in the gel, and the gel morphology changes. Characterizing ASR gel is important because the presence of fresh gel can be an indication that swelling and cracking will continue; aged, calcium-rich gels have less swelling potential and may indicate the reaction is complete. The result of these analyses can guide engineering decisions about the management of ASR-affected structures.
